**TECHNICAL VARIANCE
DOCUMENT FRONT SHEET**

Technical Variance No: **TV11807R** Date **07 August 2007**

Engine Type: **BR700-710**

Part Description: **Nacelle – Nose Cowl Lipskin**

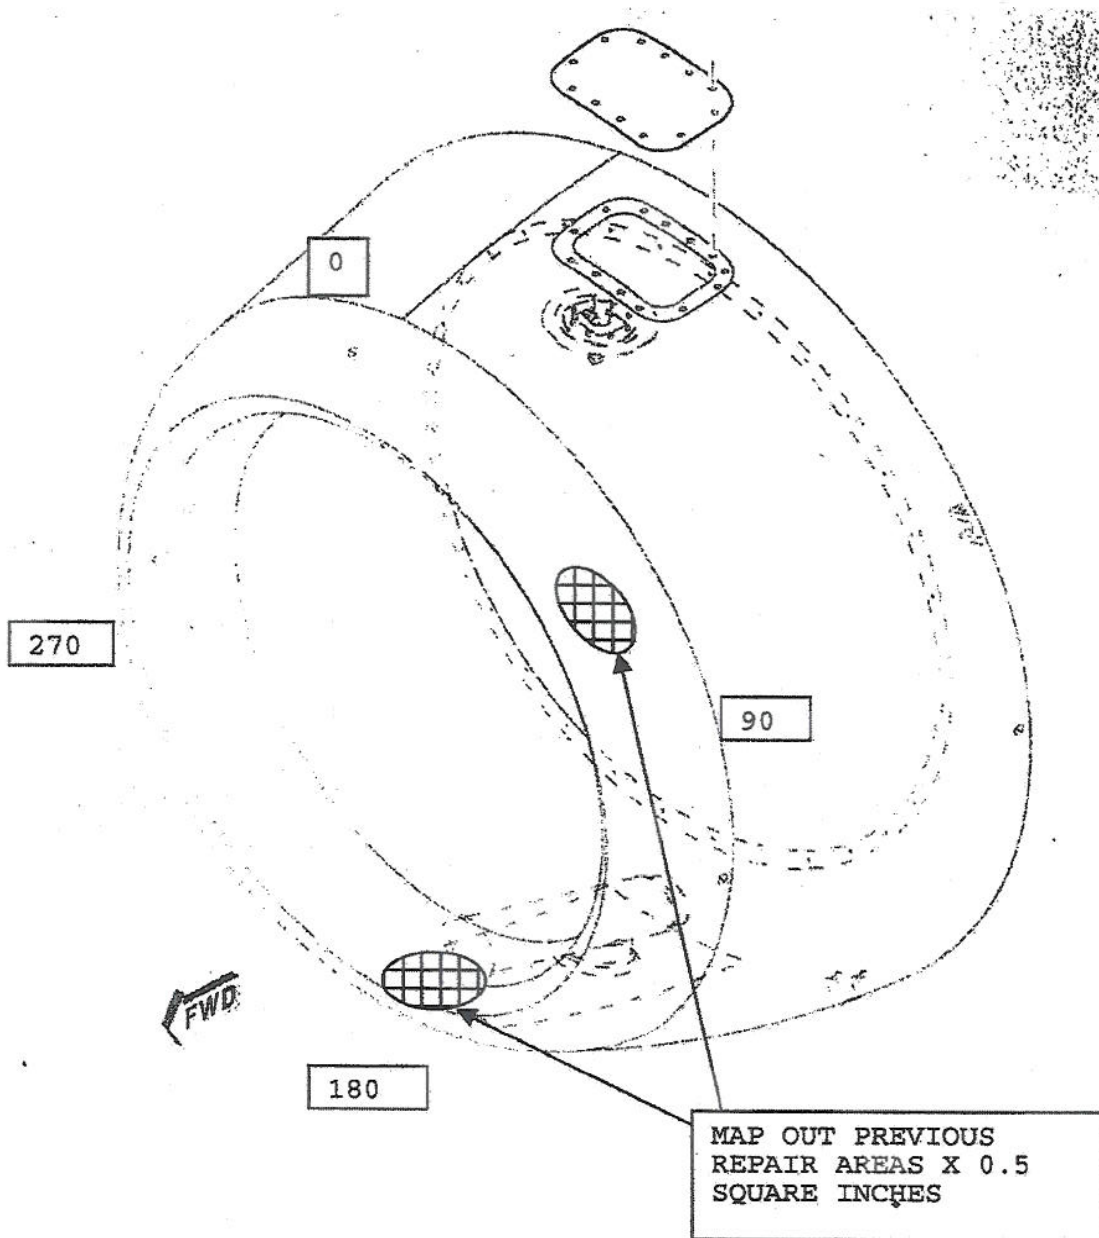
Figure 2 – Example showing 2 off repaired areas, mapped for the thickness measurement.

17.	Inspect	Inspect the lipskin to ensure that the finish is satisfactory. Check the material thickness of the repaired area. Repeat the processes detailed in op. 7 and map out the repaired area, record final Lipskin material thickness for the repaired section. Record the measurements on a suitable data sheet. Note: Minimum allowable material thickness = 0.053 inches (1.35mm)
